## Failure Analysis Of The Fracture Of The Electric Tail Spring After Electrophoresis

**Abstract:** The ultra-high strength electric tail spring produced by a spring factory broke during the compression process after electrophoresis processing. The reasons for its fracture were comprehensively analyzed by fracture morphology analysis, chemical composition analysis, metallographic structure detection and microhardness detection. The results show that hydrogen accumulates on the surface of the electric tail spring during the electrophoresis process, causing local embrittlement of the spring surface. During the compression test after electrophoresis, stress concentration occurs on the spring surface, forming a crack source at the surface embrittlement and extending the fracture.

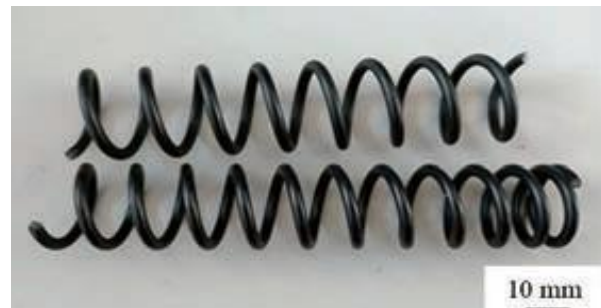
The SAE9254HV ultra-high strength electric tail spring produced by a domestic spring factory broke during the compression and testing process after electrophoresis. The broken spring is shown in Figure 1. The raw material used for this spring is ultra-high strength steel wire with a diameter of 3.8mm and a tensile strength of  $\geq 2200\text{MPa}$ . The steel wire production process is: wire rod pickling  $\rightarrow$  phosphating  $\rightarrow$  drawing  $\rightarrow$  heating  $\rightarrow$  oil quenching  $\rightarrow$  medium temperature tempering  $\rightarrow$  non-destructive

Fig1. Spring compressed and partially broken after electrophoresis

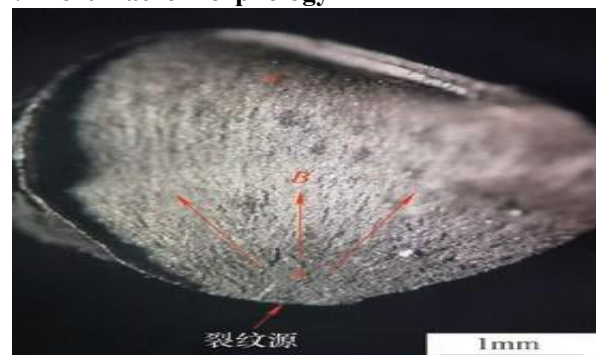
Figure 2 shows the macroscopic morphology of the spring fracture under a stereo microscope. Radial patterns can be seen on the fracture, and the crack extension lines are clear. The direction of convergence of the radial lines is the starting position of the crack [2, 3]. It can be seen that the crack originates near the

surface at point A, and the crack extends in the direction of the arrow in the figure until it breaks. The crack origin area A, crack extension area B, and terminal area C can be seen.

The observation results of the stereo microscope showed that the crack source originated from a surface near the edge of the spring, and then expanded radially, eventually leading to the fracture of the spring (see Figure 2). The microscopic fracture of the crack source area was observed, and it was found that the fracture source area near the material surface showed the fracture characteristics of intergranular fracture; the fracture in this area was a rock candy-like intergranular fracture, and there were intergranular cracks between the grains, with typical microscopic morphological characteristics of hydrogen-induced fracture [6-9]. Analysis showed that it might be caused by hydrogen embrittlement. After checking the steel wire processing

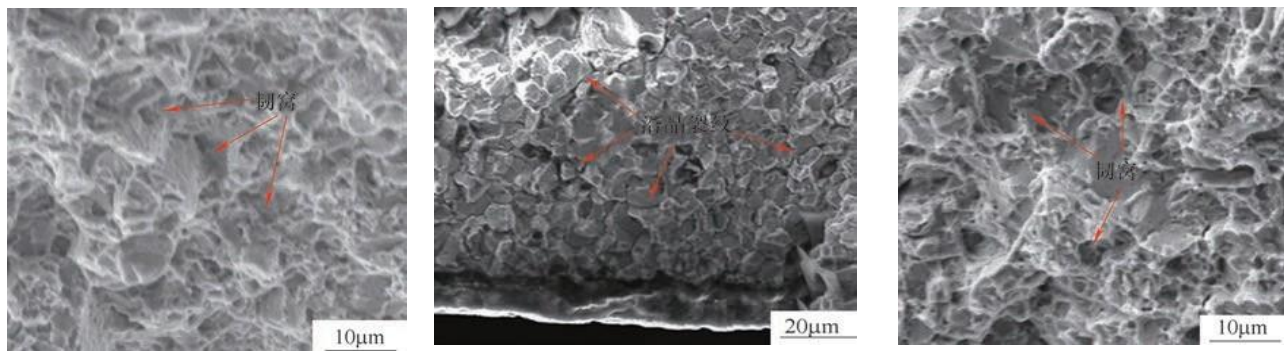
Fig.3 Microstructure of different areas of spring fracture

The fracture morphology was observed under a scanning electron microscope. The microscopic morphology of each region is shown in Figure 3. No defects such as inclusions and folds were found. As shown in Figure 3a, the crack origin zone is mainly intergranular fracture, and the grains crack along the grain boundaries. The grain boundaries in this area have been significantly weakened and brittle. Starting from the crack origin zone, the crack continues to expand

radially inward. After the intergranular fracture zone, the cross-sectional characteristics gradually transition to dimples. This area is the stable expansion zone of the cross section (see Figure 3b). As shown in Figure 3c, the final fracture zone presents a dimple morphology, and the number of dimples increases. Most areas of the spring cross section (expansion zone + final fracture zone) have dimples, indicating that the material has good plasticity.

a) Crack source area (position A) b) Crack extension zone (position B) c) Termination zone (C position)

( 1) When electrophoresing the spring, on the premise of ensuring the quality of the electrophoresis layer, the electrophoresis time should be shortened as much as possible to prevent local hydrogen corrosion and cause local embrittlement of the spring surface.

( 2) After electrophoresis, try to use effective dehydrogenation technology, such as heating dehydrogenation.

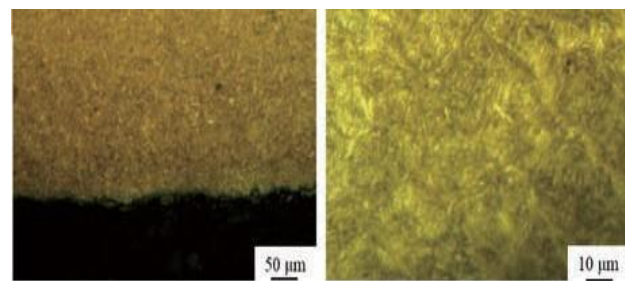
near the spring fracture, and after mounting, sandpaper grinding and mechanical polishing, it was corroded with a 4% volume fraction nitric acid alcohol solution. Under the metallographic microscope, it was observed that the matrix structure was tempered troostite, there was no obvious decarburization at the edge of the sample, and the structure was uniform and normal, as shown in Figure 4. Therefore, the influence of decarburization and abnormal structure of the steel wire can be ruled out.

a) Edge area b) Heart area  
Fig.4 Microstructure of broken spring

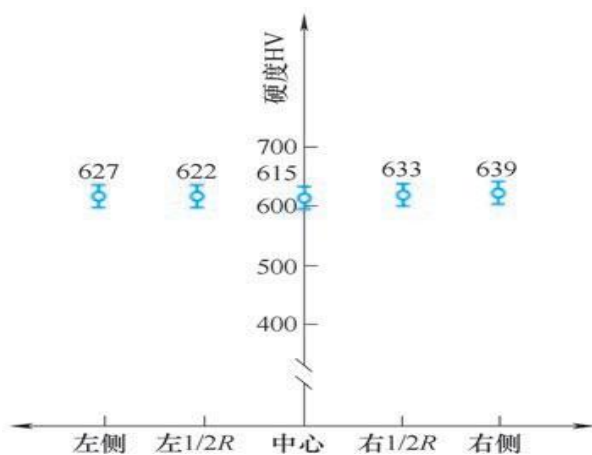
Samples were taken near the spring fracture for microhardness testing, and the results are shown in Figure 5. As can be seen from Figure 5, the hardness of the edge is higher, the hardness of the core is slightly lower, and the hardness decreases slightly from the edge to the core, which is in line with the hardness law of spring steel after quenching and tempering of the steel wire; the maximum hardness is 639HV, the minimum is 615HV, and the maximum difference is 24HV. The hardness values of the edge and the core are not much different, and the hardness distribution is generally uniform, which also proves the overall uniformity of the organization from the side.

Fig.5 Microhardness distribution of the cross section of the broken spring
